# Resilience of educational infrastructure in Nepal: A mixed methods approach to structural and functional assessment

Kishor Badu<sup>1</sup>, Khem Raj Joshi<sup>1</sup>, Dipesh Dhami<sup>1</sup>, Dipak Raj Bhatt<sup>1</sup>, Shriya Bohara<sup>1</sup>, Bhim Kunwar<sup>1</sup> and Birendra Kumar Bohara<sup>2\*</sup>

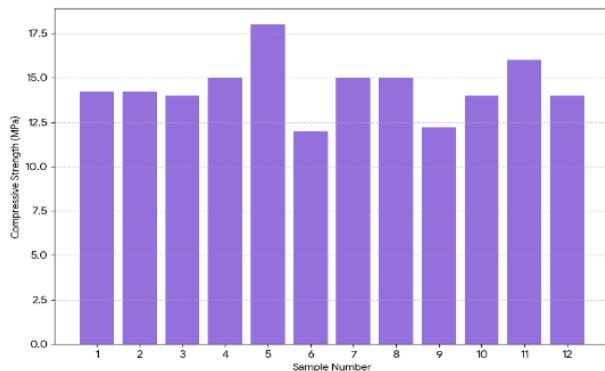
**Figure 2.** Compressive strength of wall 1 by Rebound test

(Pathirana & Savitha, 2023; Wickramathilake & Hemachandra, 2025) NDT using the Rebound Hammer method and visual inspections provided quantitative and qualitative insights. Rebound Hammer Test results showed average compressive strengths of 14.46 MPa for masonry walls (range: 12–18 MPa), 17.0 MPa for masonry columns (12–24 MPa), and 17.4–26.63 MPa for reinforced concrete slabs and beams shown in Figures 2 to 9. These values indicate adequate capacity for current occupancy but fall short of the robustness needed for high seismic zones. Localized low readings (below 13 MPa) suggest material degradation or stress concentration. Visual inspections identified critical distress, including longitudinal cracks near beam supports and slab joints, indicating poor bonding between structural and non-structural elements, which compromises lateral stability. Diagonal shear cracks around window and door openings signal seismic vulnerability shown in figure 10. Additional defects include moisture seepage, corroded window frames, rotting wooden doors (see figure 10), peeling paint, and ceiling stains, reflecting environmental exposure and poor maintenance these types of similar study also suggested in [34], [35]. A significant compliance issue is the absence of expansion joints, despite the building's elongated footprint exceeding the length-to-width ratio per NBC 205:1994, Clause 7.5 [20]. The combination of adequate but variable material strength, environmental deterioration, irregular plan shape, and non-compliance with expansion joint requirements necessitates immediate intervention

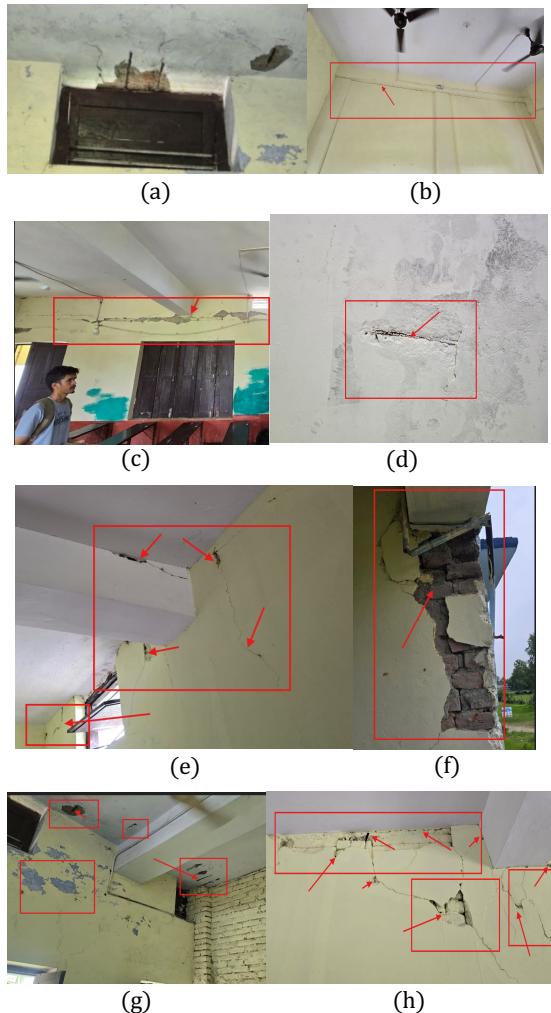
**Figure 10.** Defects observed in the building: (a), (d), (g) Accelerates deterioration of reinforcements and finishes; reduces durability and aesthetic quality; often due to environmental exposure and lack of protective coatings; (b) Longitudinal cracks near beam supports and slab joints (indicating poor bonding between structural and non-structural elements); (c), (e), (g), (h) Diagonal shear cracks around beam, wall corners, window and door openings (Signaling seismic vulnerability).

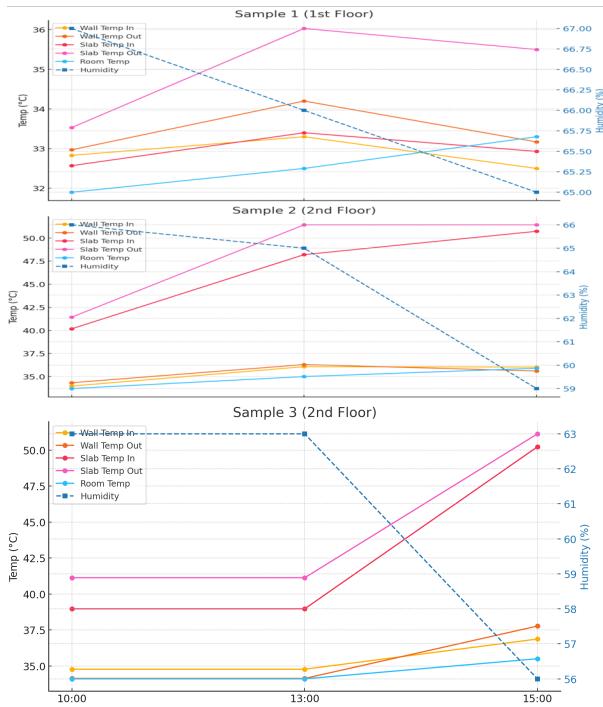
Temperature and relative humidity were recorded at three-time intervals (10:00, 13:00, and 15:00) in three sample rooms on August 24, 2025 (2082/04/09). The results revealed a clear diurnal heating trend, with all building elements warming steadily throughout the day. On the second floor, indoor slab temperatures peaked at 51.43 °C (Sample 2) and 51.13 °C (Sample 3) by 15:00, indicating extreme heat gain from the roof. First-floor slabs remained significantly cooler, peaking at 35.5 °C shown in Figure 11. Relative humidity showed an inverse trend, starting higher in the morning (63-67%), dropping by midday, and reaching a low of 56% in the hottest second-floor room. The temperature humidity relationship confirmed that as indoor temperatures rose, air moisture content declined, resulting in a hotter and drier environment conditions that exacerbate occupant discomfort. This effect was most pronounced in upper-floor classrooms, where ceiling proximity to the uninsulated roof amplified heat gain [27], [38].

**Figure 11.** Temperature, Humidity and Time Graph (Diurnal Variation of Temperature and Relative Humidity in Sample Rooms)
