# Resilience of educational infrastructure in Nepal: A mixed methods approach to structural and functional assessment

Kishor Badu<sup>1</sup>, Khem Raj Joshi<sup>1</sup>, Dipesh Dhami<sup>1</sup>, Dipak Raj Bhatt<sup>1</sup>, Shriya Bohara<sup>1</sup>, Bhim Kunwar<sup>1</sup> and Birendra Kumar Bohara<sup>2\*</sup>

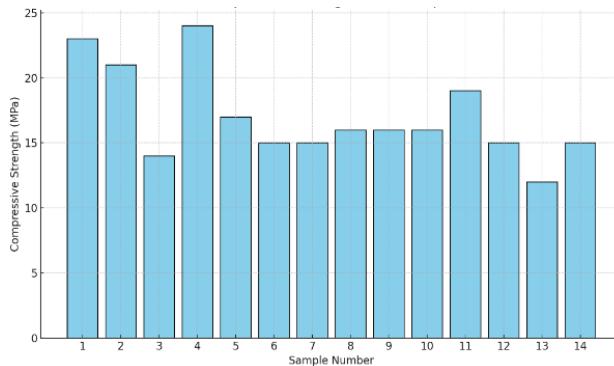
**Figure 3.** Compressive strength of masonry column by Rebound test

(Pathirana & Savitha, 2023; Wickramathilake & Hemachandra, 2025) NDT using the Rebound Hammer method and visual inspections provided quantitative and qualitative insights. Rebound Hammer Test results showed average compressive strengths of 14.46 MPa for masonry walls (range: 12–18 MPa), 17.0 MPa for masonry columns (12–24 MPa), and 17.4–26.63 MPa for reinforced concrete slabs and beams shown in Figures 2 to 9. These values indicate adequate capacity for current occupancy but fall short of the robustness needed for high seismic zones. Localized low readings (below 13 MPa) suggest material degradation or stress concentration. Visual inspections identified critical distress, including longitudinal cracks near beam supports and slab joints, indicating poor bonding between structural and non-structural elements, which compromises lateral stability. Diagonal shear cracks around window and door openings signal seismic vulnerability shown in figure 10. Additional defects include moisture seepage, corroded window frames, rotting wooden doors (see figure 10), peeling paint, and ceiling stains, reflecting environmental exposure and poor maintenance these types of similar study also suggested in [34], [35]. A significant compliance issue is the absence of expansion joints, despite the building's elongated footprint exceeding the length-to-width ratio per NBC 205:1994, Clause 7.5 [20]. The combination of adequate but variable material strength, environmental deterioration, irregular plan shape, and non-compliance with expansion joint requirements necessitates immediate intervention
